# WETLAND MAPS

# THE AERIAL MAPS

# Lippold Park Then and Now

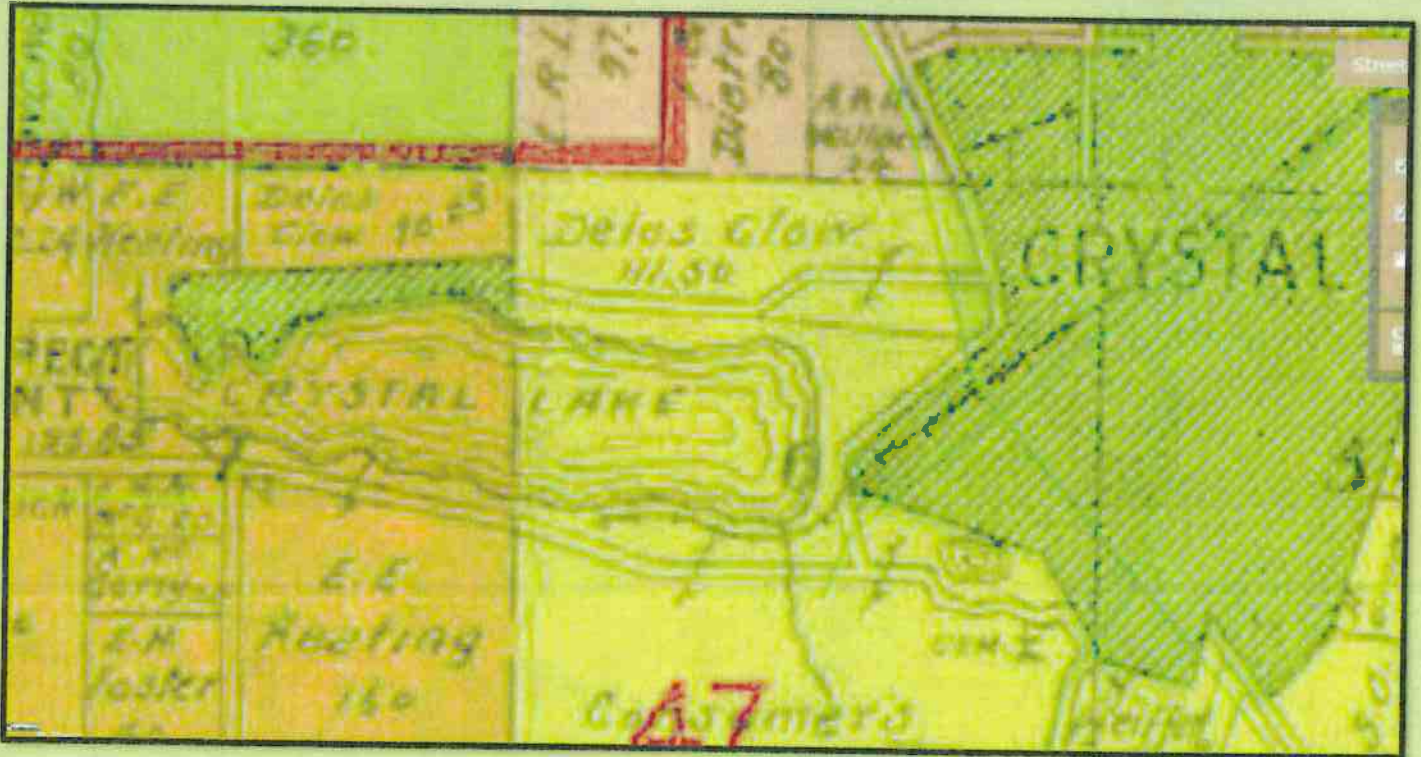
ETCHED AREAS DESIGNATED AS "TIMBER"

URBAN/RES DEVELOPMENT AREAS SHOW IN HATCHED GREEN  
(CLDD BUILT ABOUT 6 YEARS EARLIER, THE DAM/WIER ABOUT 8 YEARS EARLIER)

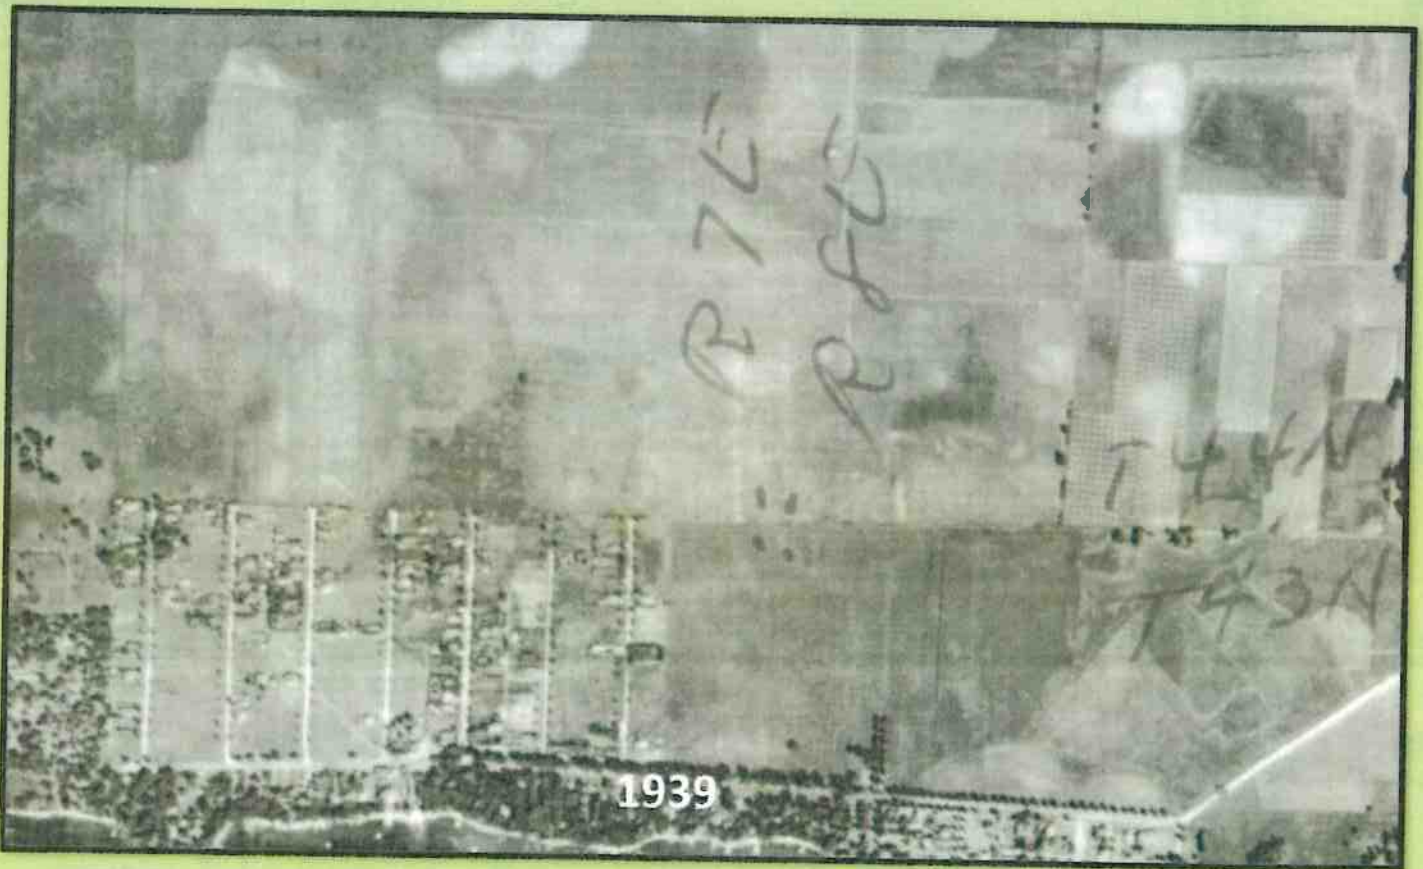
Drain Tile Systems Used Widely for Farming  
North of CL with the 1917 Drainage District Tile System

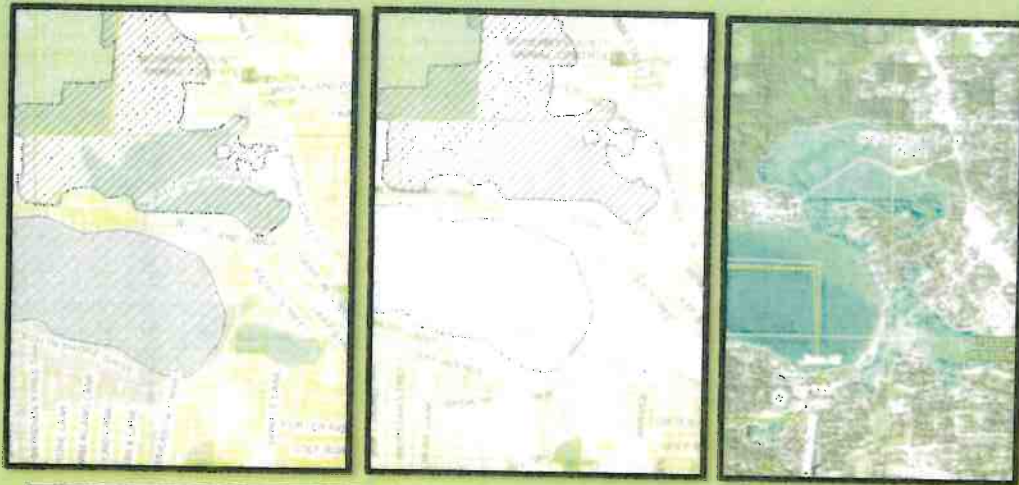
FLOOD PLAIN CHANGES OVER TIME  
BFE 982.6 HISTORIC  
BFE 893.0 CURRENT

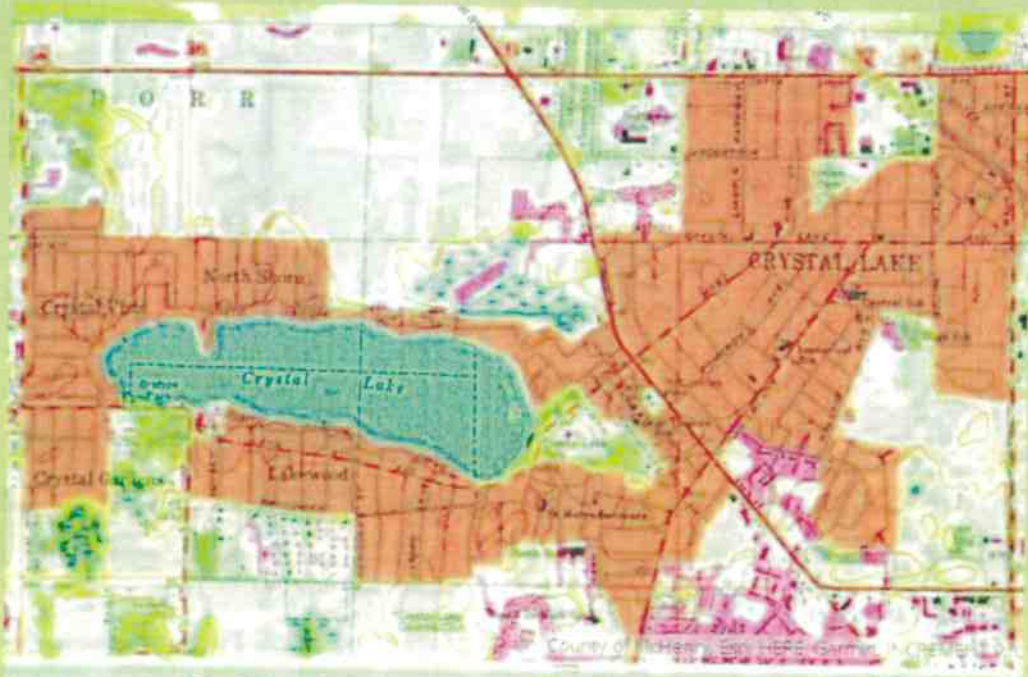
**BEFORE 1992**

1980 Wetlands (lime green) - largely unchanged since 1925

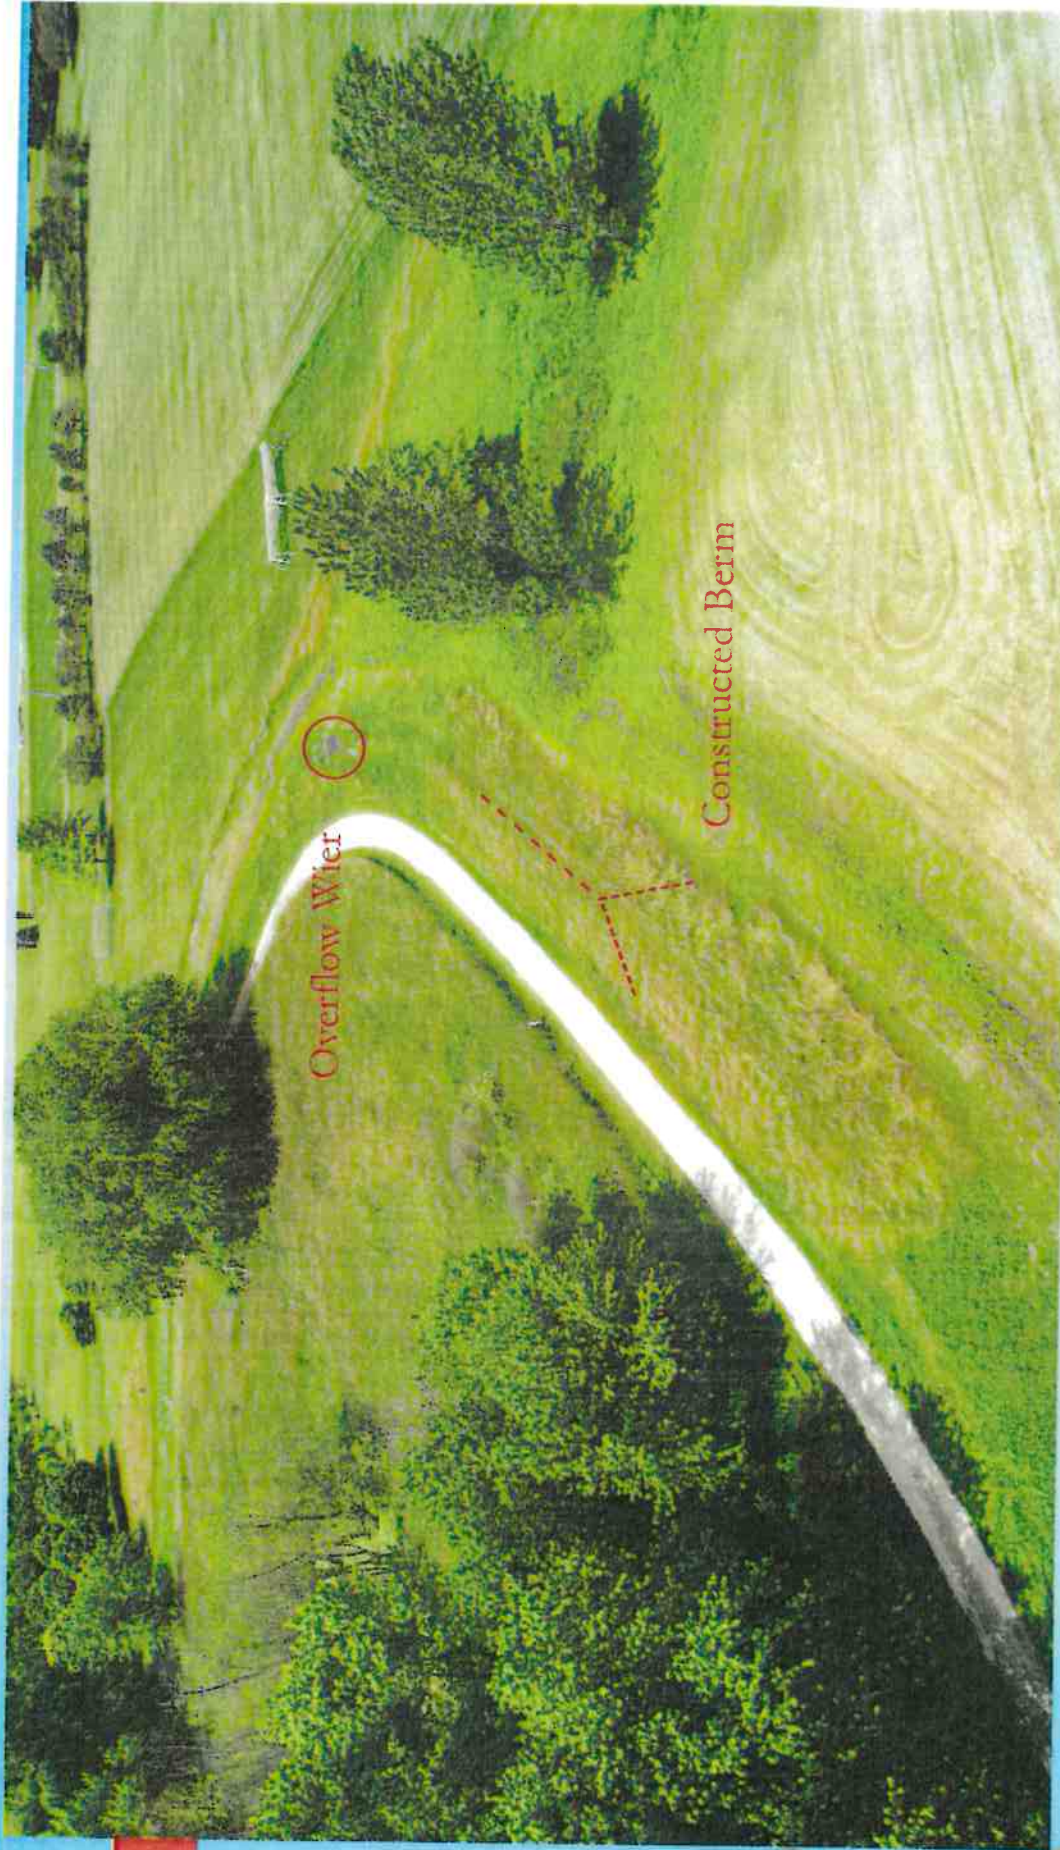
2019

Overflow Wier

Constructed Berm

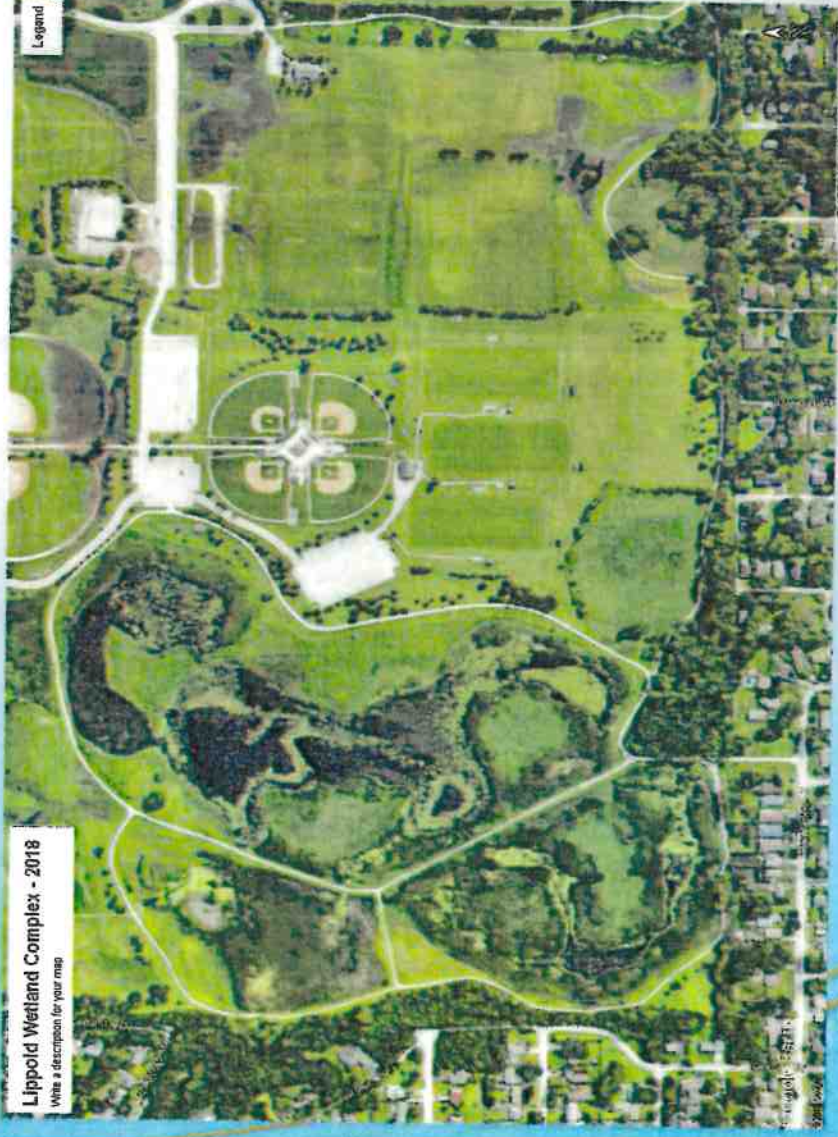
# Improvements for Water Quality Protection

- Removed channelized sections of drainage ditch with multiple wetland complexes and trail network
- Eliminated “short circuiting” of runoff from north of 176 and sod farm
- Greatly reduced suspended muck soil particles from entering Crystal Lake proper
- Physical and biological treatment of non-point source pollution
- Work was not required by any regulatory agency

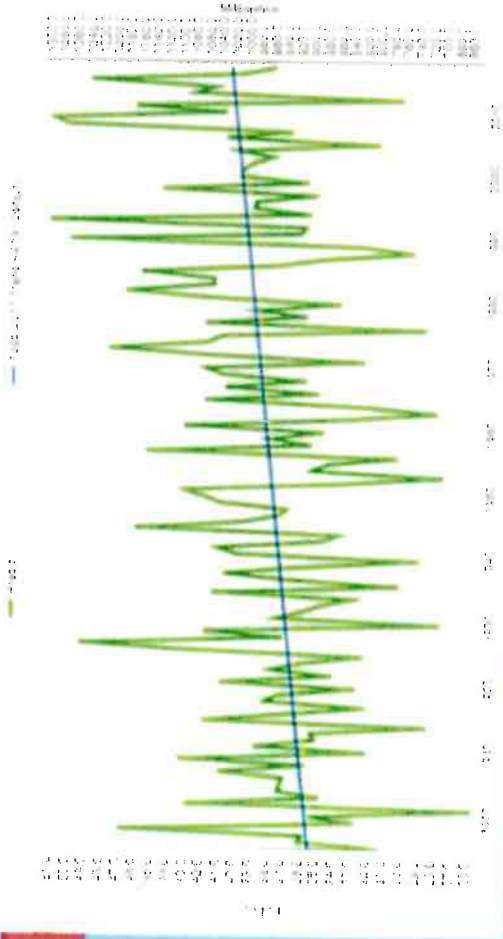
Illinois. Precipitation, January-December

- Rainfall is “different” over the last few decades statewide
- Rainfall patterns have contributed to “nuisance” and major flooding frequencies
