## Park District Board of Commissioners Special Meeting Minutes November 19, 2015

DATE: November 11, 2015  
TO: Park Board of Commissioners  
FROM: Ann Viger, Director of Planning and Development  
SUBJECT: Main Beach Playground Replacement Options

## Playground Assessment Report

**Playground Name:** Regatta Playground at Main Beach

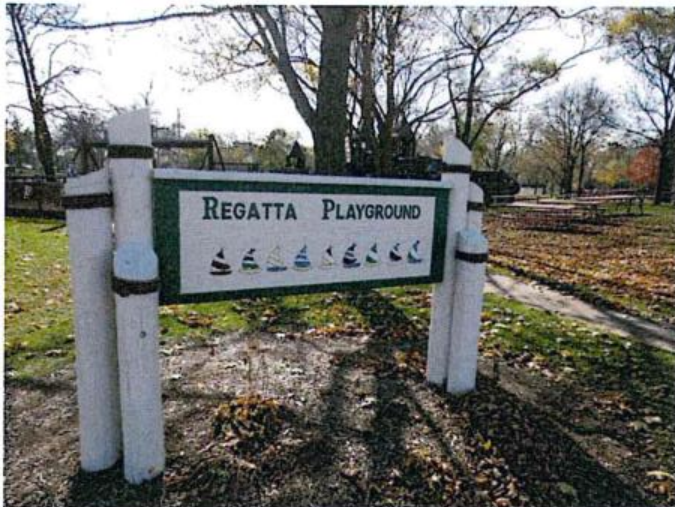
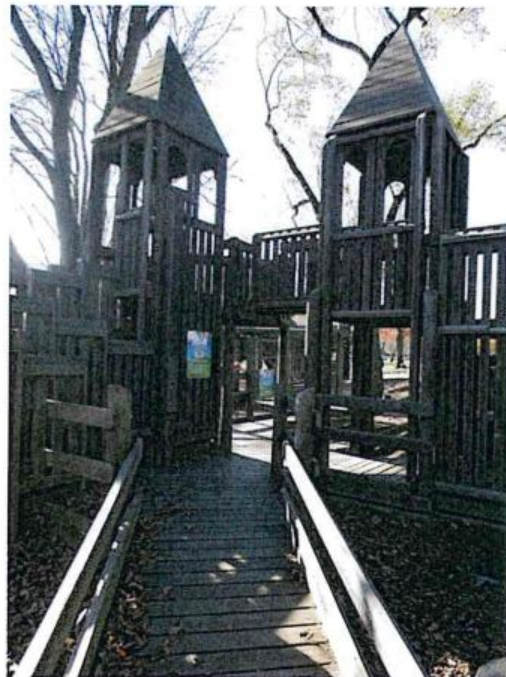
The playground was built in 1994 and is in medium condition.

The playground is 21 years old. The playground should be expected to last around 20 years with proper maintenance. The original materials used in the playground were pressure treated wood poles and treated framing. The original wood was treated with CCA. Wood was used for decking.

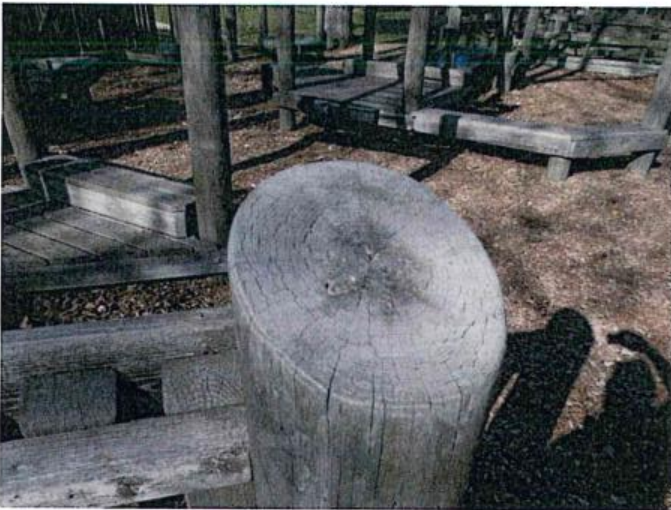
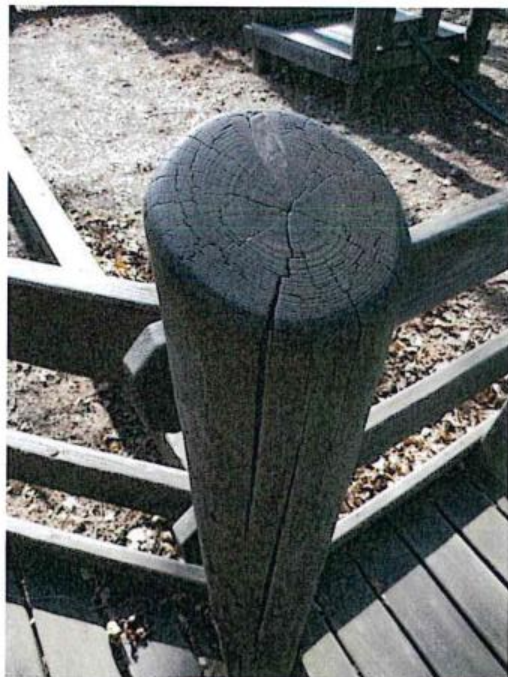
**Main support posts**

Poles seem to be in generally very good shape. They've been well sealed through the years. Some surface cracking and splitting is evident. They seem to be solid below grade.

Stain/seal with solid body stain & seal with EPL coating.

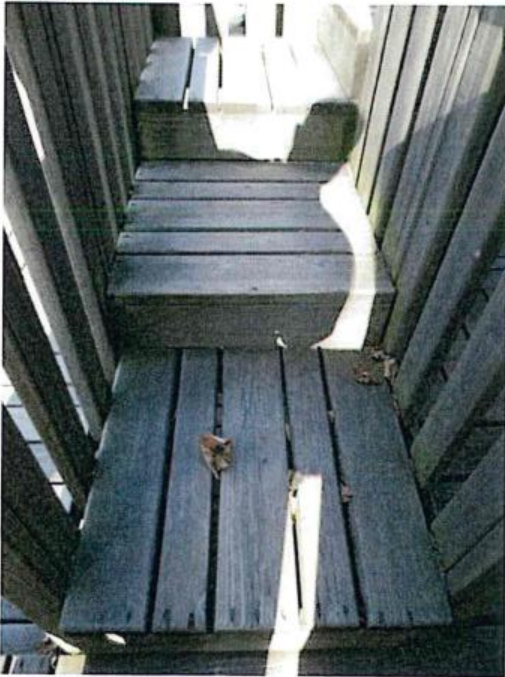
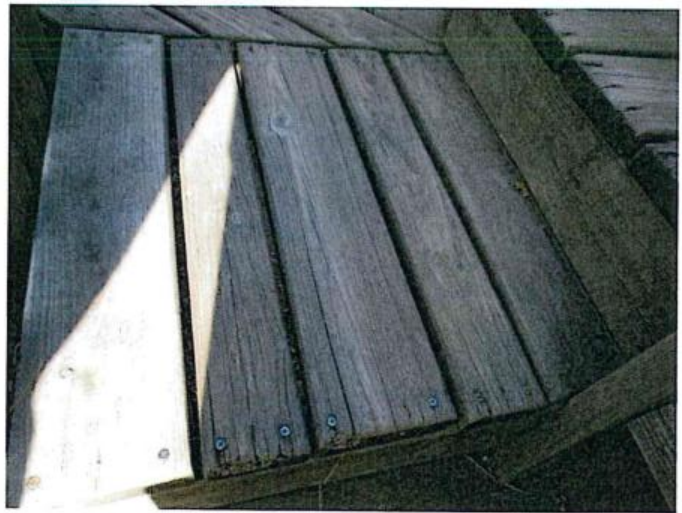
**Decking**

The decking is in medium condition. Some splintering but not structural.

Replace with recycled plastic

Option 2: Leave as is and stain with Solid Body Stain

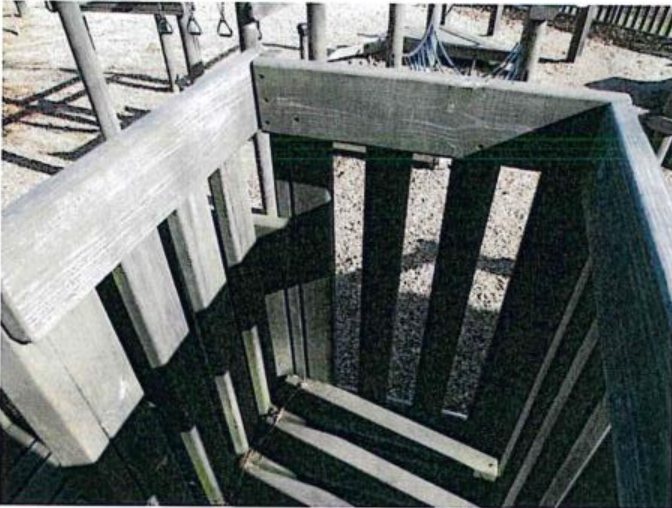
**Handrails**

The handrails are in medium condition. Some splintering but not structural.

Replace with recycled plastic

*Option 2:* Leave as is and stain with solid body stain.

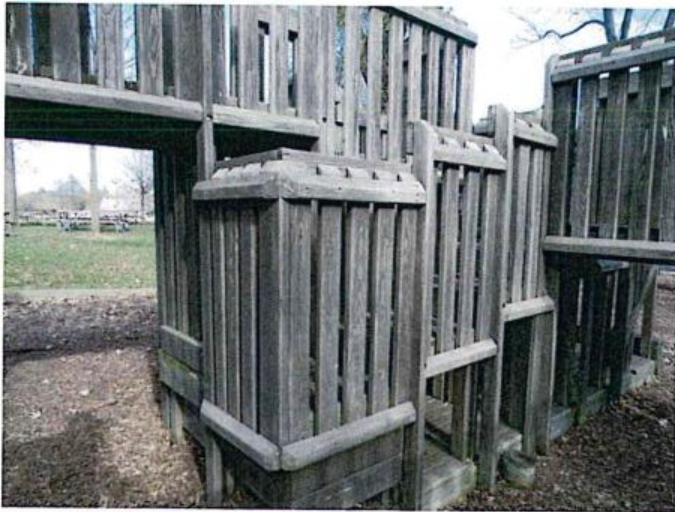
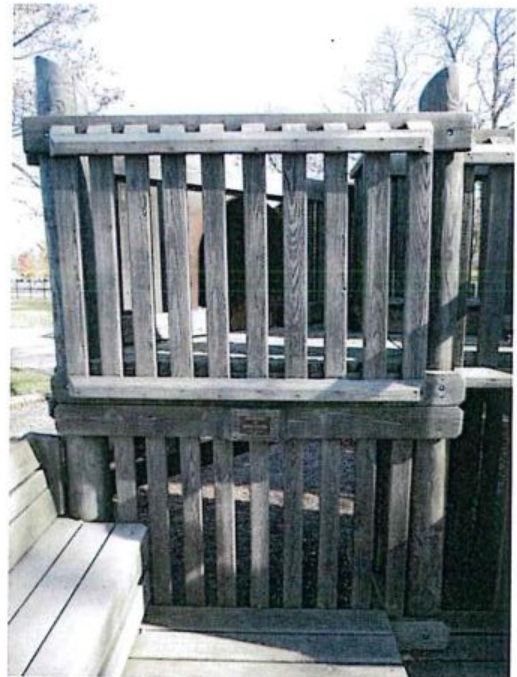
**Balusters**

The balusters are in medium condition (minor splintering & wear).

Replace with recycled plastic balusters.

*Option 2:* Leave as is and stain with solid body stain.

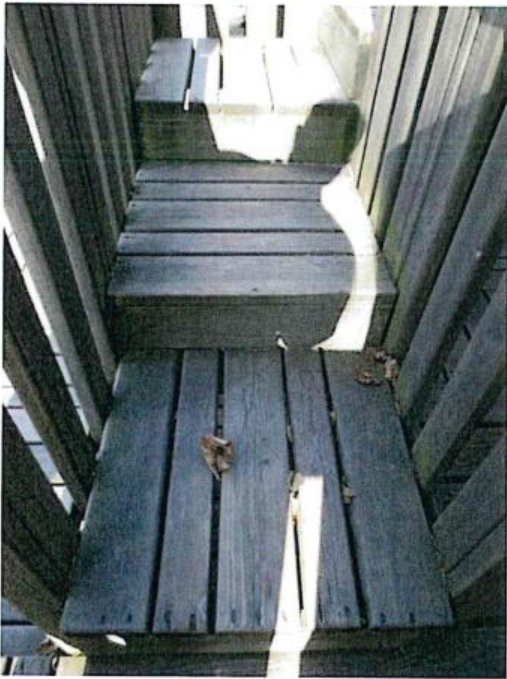
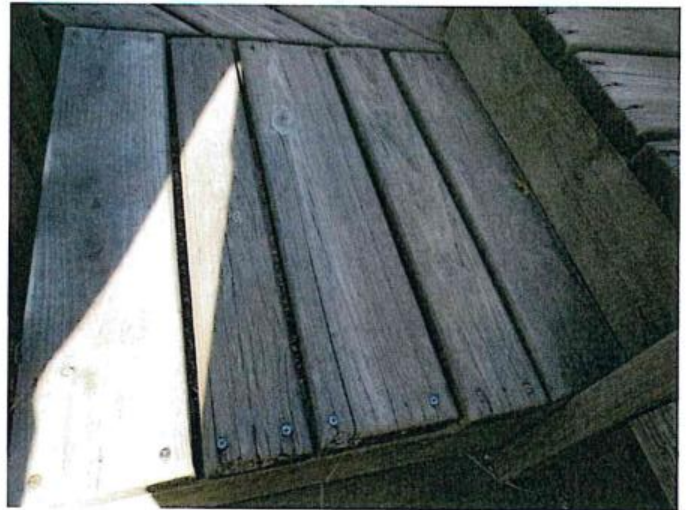
**Maze cubes**

The maze cubes are in medium condition (minor splintering & wear).

Replace the decking with recycled plastic decking

*Option 2:* Leave as is and stain with solid body stain.

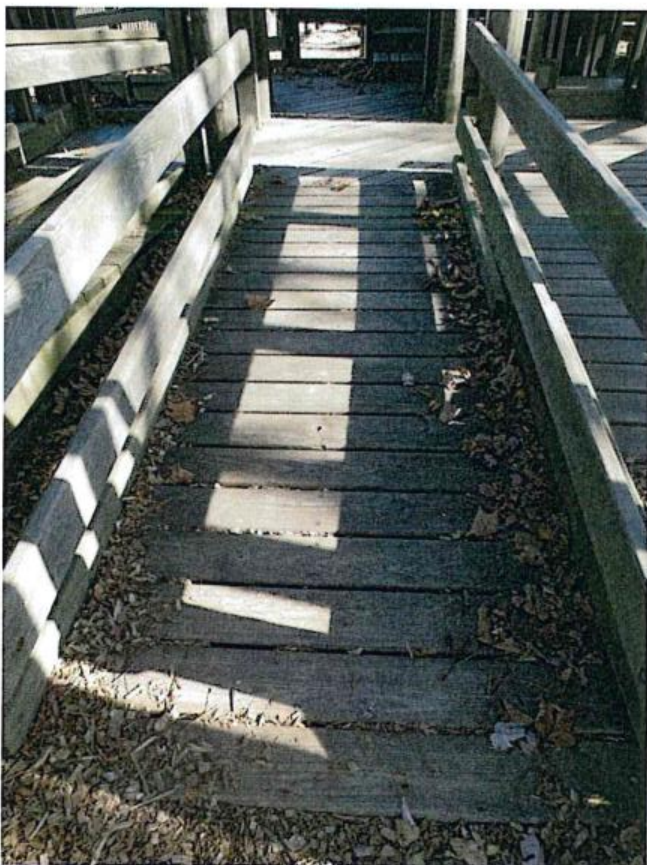
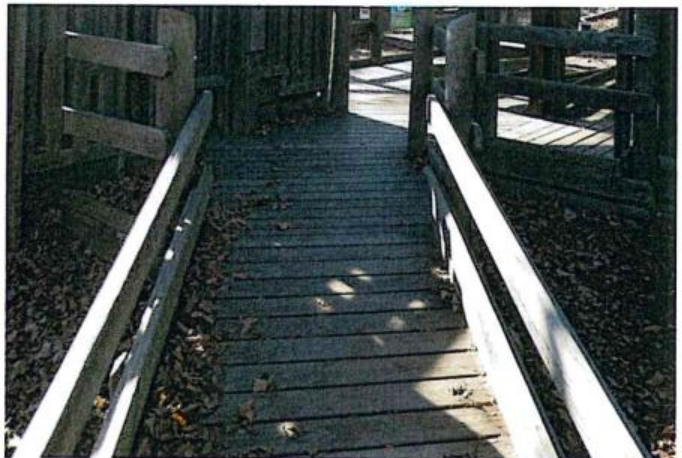
**Accessible ramps**

**Comments:** Ramp framing is in good to fair condition. Decking is in fair condition. Some of the ramps are inaccessible because of a lack of EWF creating an accessible approach.

Install new recycled plastic decking

*Option 2:* Leave as is and stain with solid body stain.

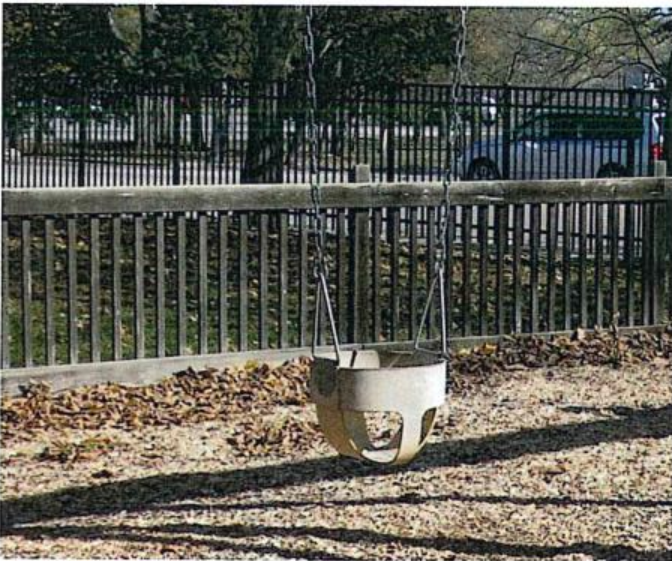
**Fence**

The fence is in medium condition (minor splintering, missing pickets and wear).

Replace missing/poor condition pickets. Stain with solid body stain.

*Option 2: replace with a recycled plastic versions. Names on the pickets could be used as a fundraiser.*

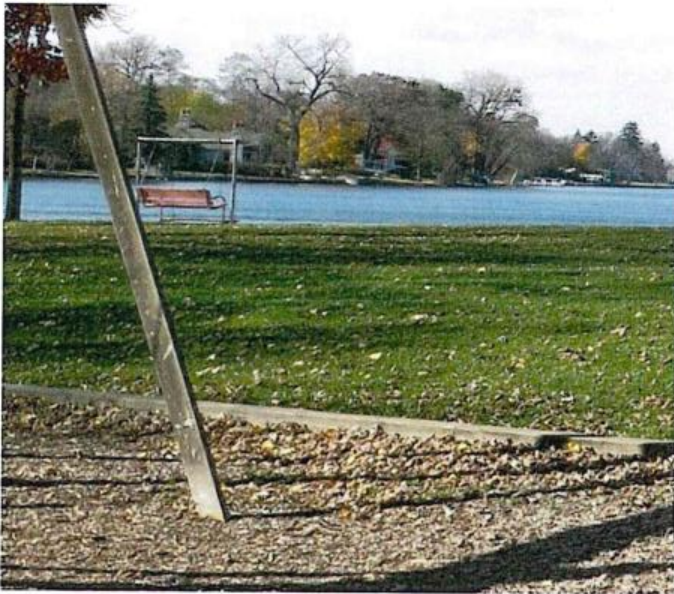
**Low perimeter**

Perimeter is in medium condition.

Replace loose or missing pieces.

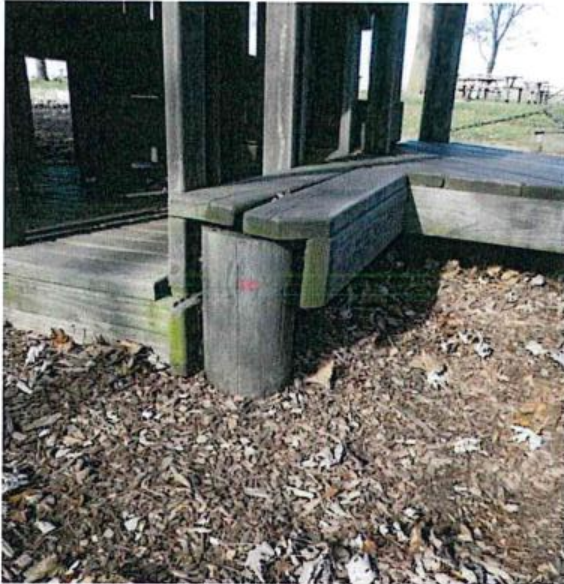
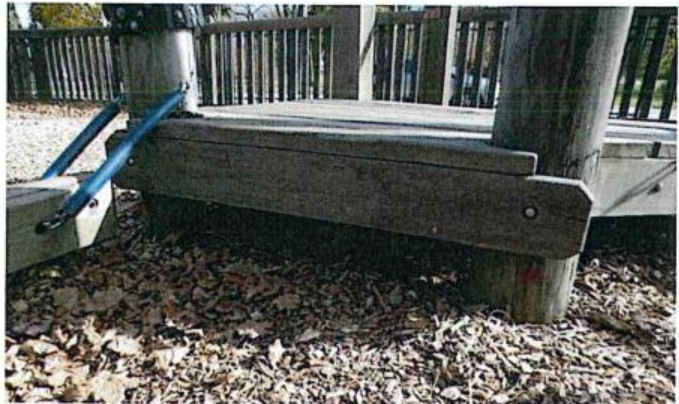
**Safety Surfacing**

**Type of surfacing:** Appears to be engineered wood fiber. Confirm existing material meets ASTM standards

Safety surfacing is in poor condition. Many areas are not at sufficient depth.

Add additional engineered wood fiber to a total depth of 12" throughout.  
Make sure the finished safety surfacing meets all safety requirements.

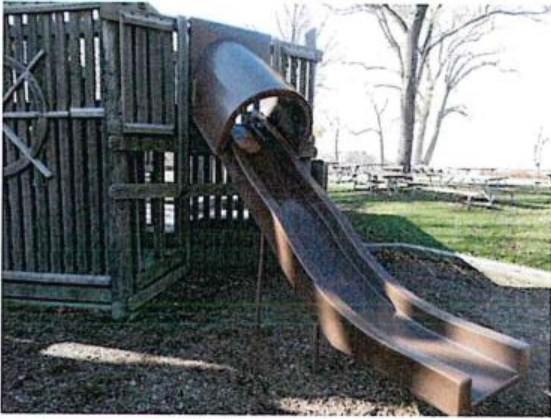
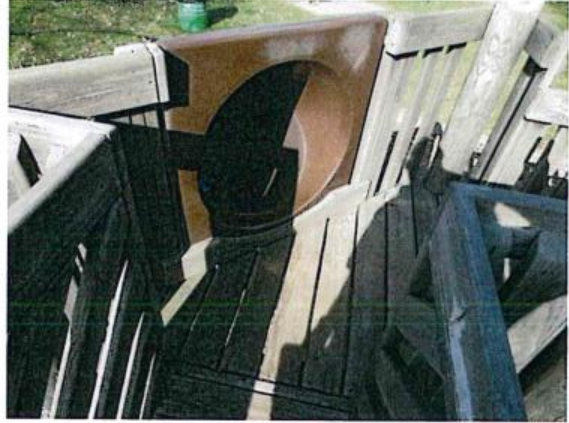
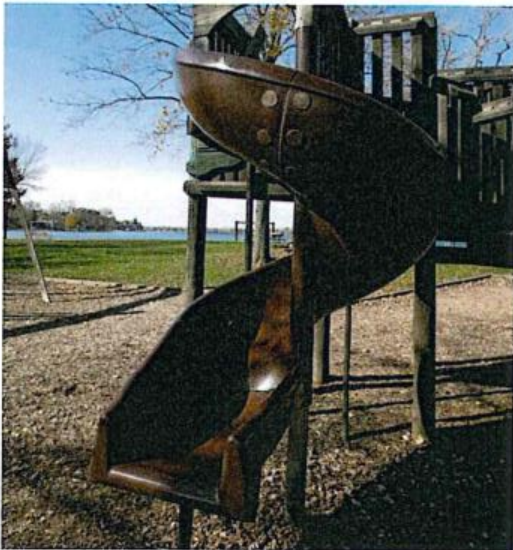
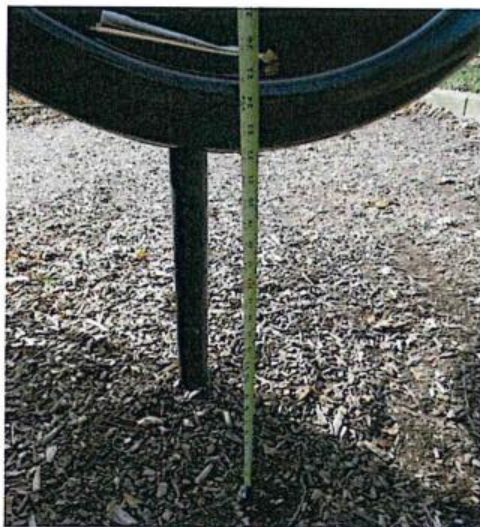
**Equipment type/name:** Slides

Slides are in good to fair condition.

Leave slides “as-is”

*Option 2: replace with new slides.*

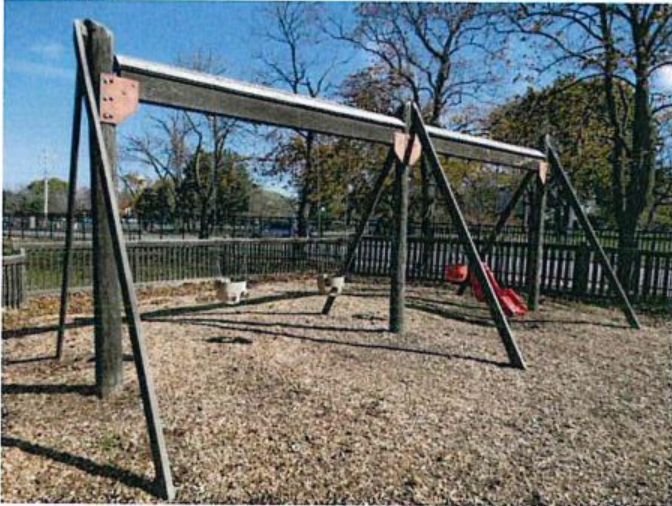
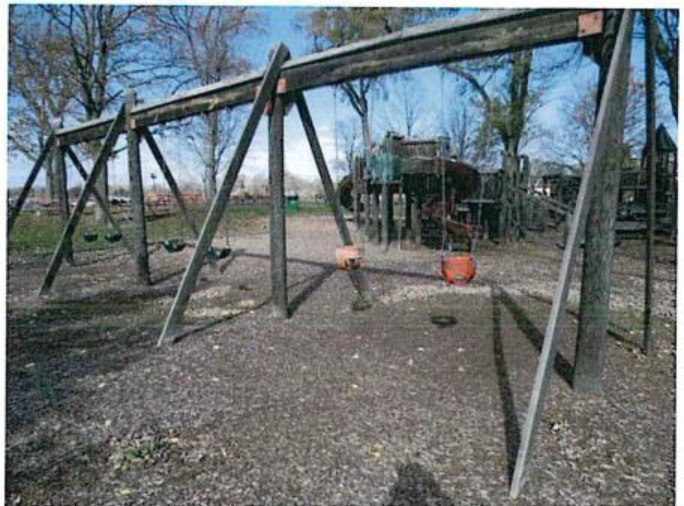
Equipment type/name: **Swings**

Swings are in fair to good condition. Swing beams seem solid. Some swing brackets are fairly loose.

Replace swings with newer, modern looking models.

*Option 2:* Tighten up swing brackets as necessary. Stain wooden swing beams and posts with Solid Body Stain.

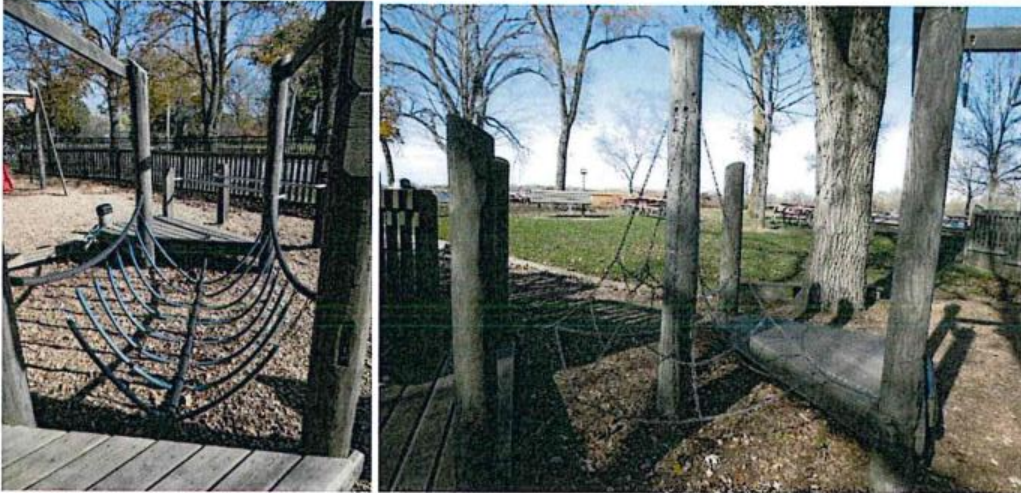
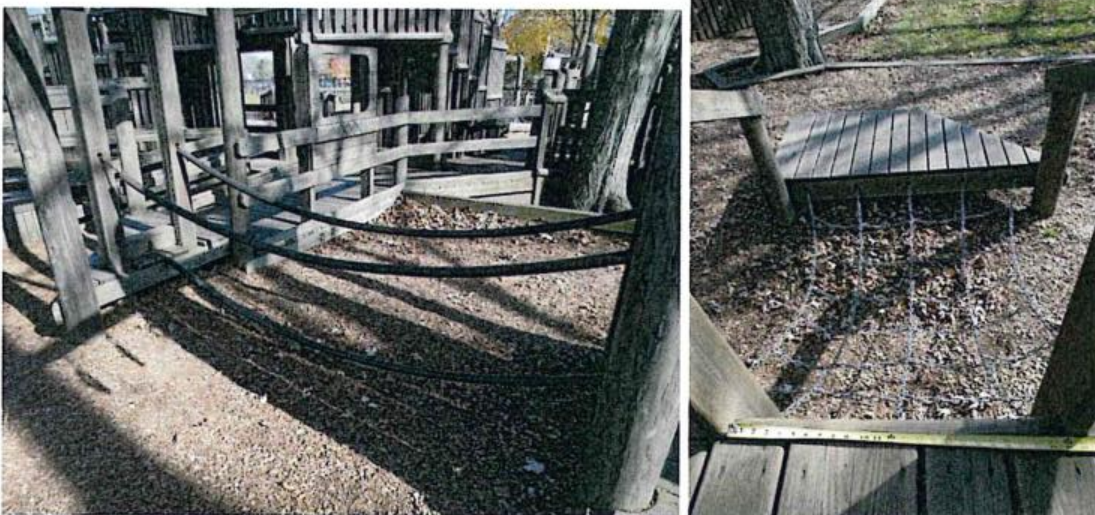
**Equipment type/name:** Hose and chain climbing equipment – Cradle Bridge, chain bridge, cargo net, ships rigging soft climber

Exposed chain and wear

Replace with new cable versions

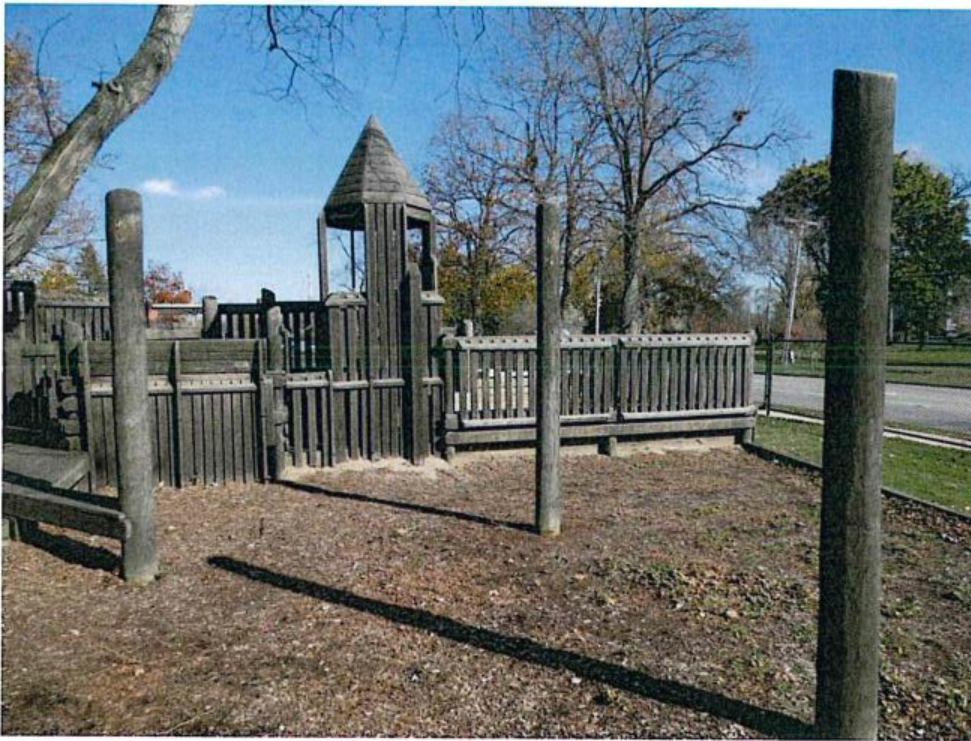
**Equipment type/name:** Trolley Ride

Has been removed

Replace with new manufactured version

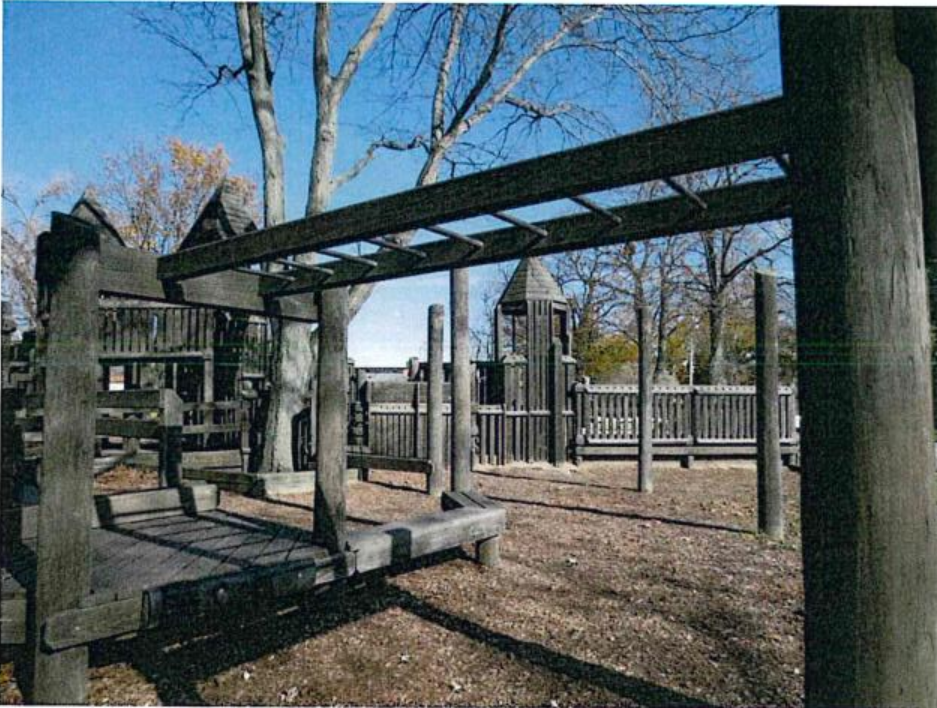
**Equipment type/name:** Horizontal Ladder

Original Wooden Structure – Appears sound, but has splinters and cracking.

Replace with manufactured version

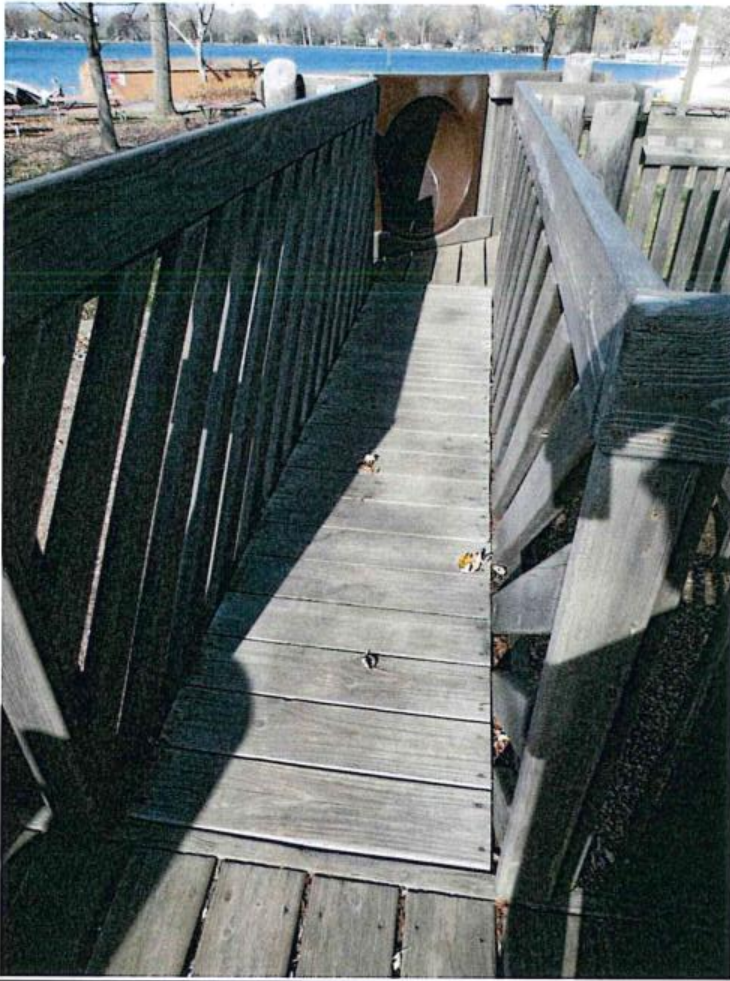
**Equipment type/name:** Suspension Bridge

Original Suspension Bridge has been removed and replaced with a straight “cat-walk.” The original wood framing is cracked and splintered. Deck is worn. Handrails are worn and splintered.

Replace entire suspension bridge; framing, handrails, balusters and deck with new structural plastic framing and decking to match other areas.

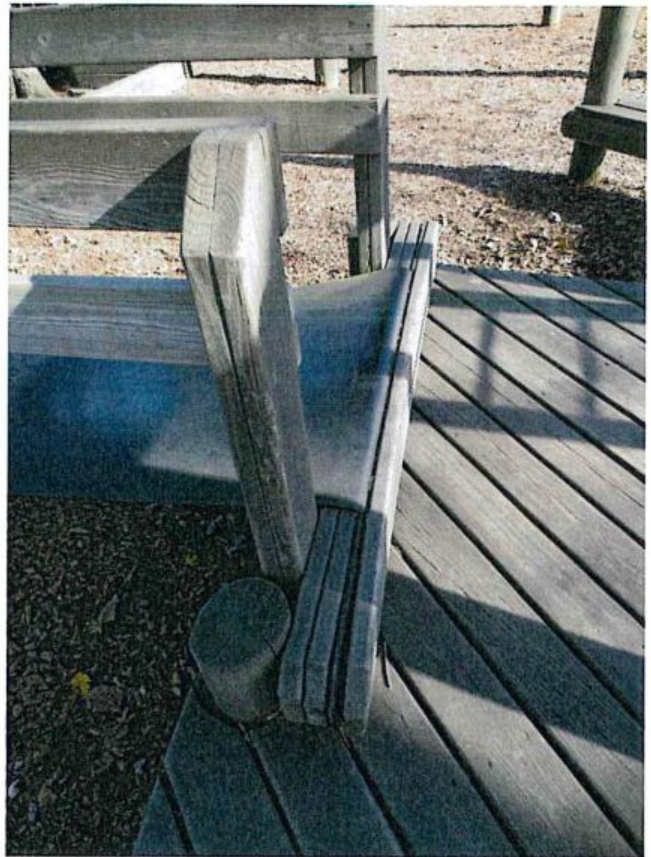
**Equipment type/name:** Rubber Bridge

Original Wood Framing is cracked and splintered. Handrails are worn and splintered. Rubber has been replaced. It is now sagging and loose.

Replace with updated recycled plastic version

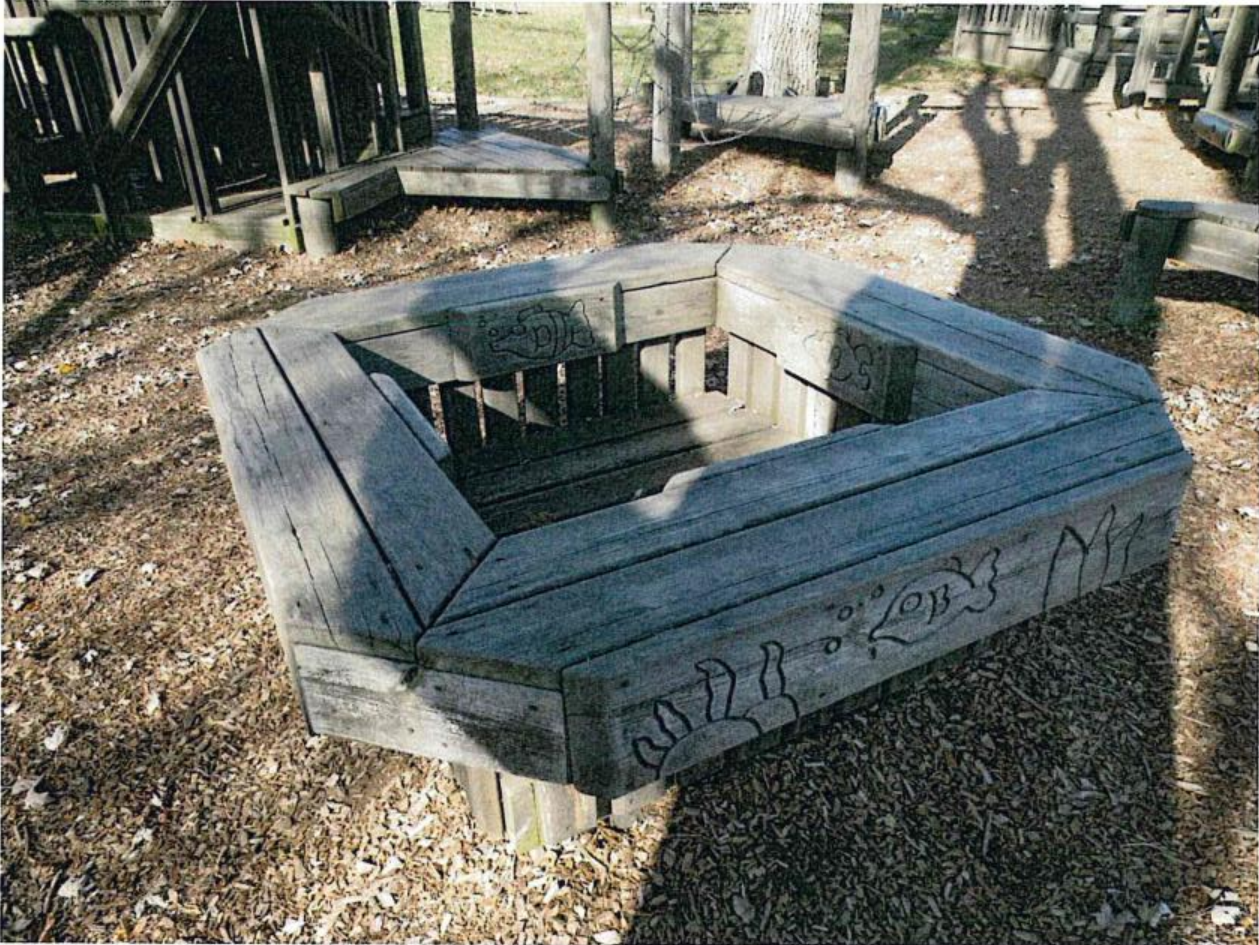
**Equipment type/name:** “Fish Bowl” Bouncer

Chains connecting apparatus to decks have been removed. The “bouncer” still functions as a “stand-alone” apparatus. Original wood framing and decking is worn and splintered.

Replace with new apparatus

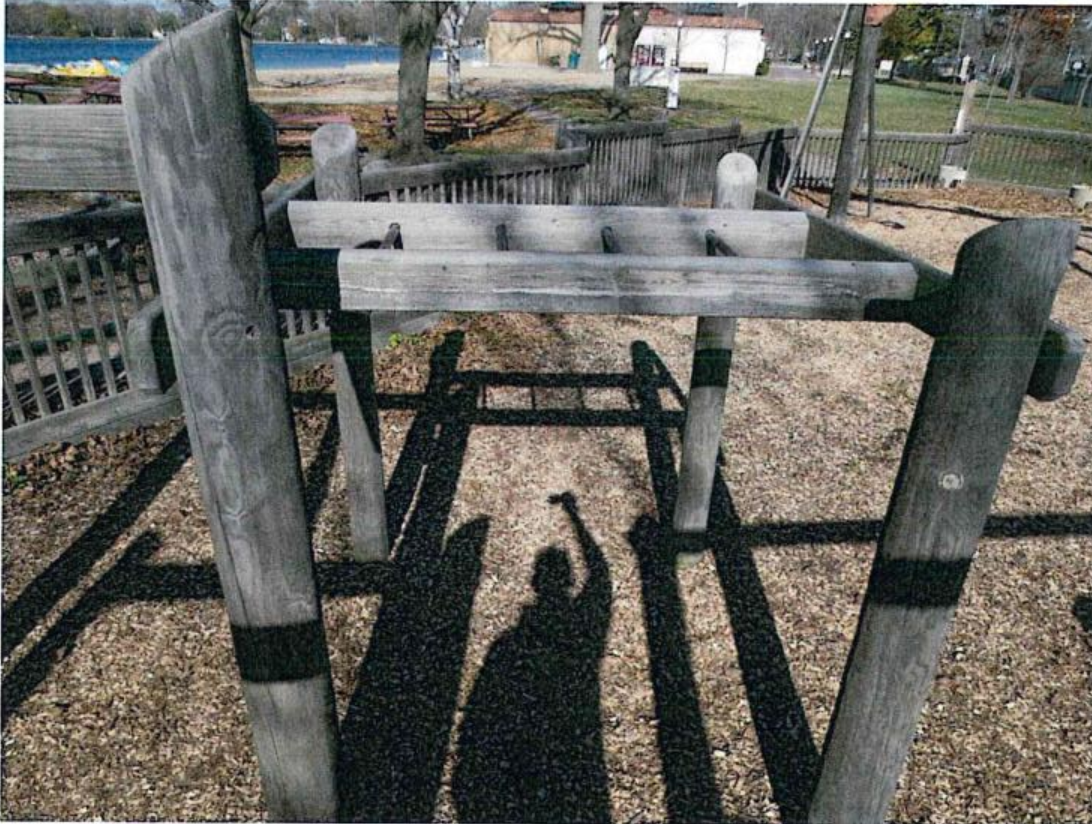
**Equipment type/name:** Low Ladder (Tot Lot)

Original Wood Framing is weathered cracked and splintered.

Replace with manufactured version

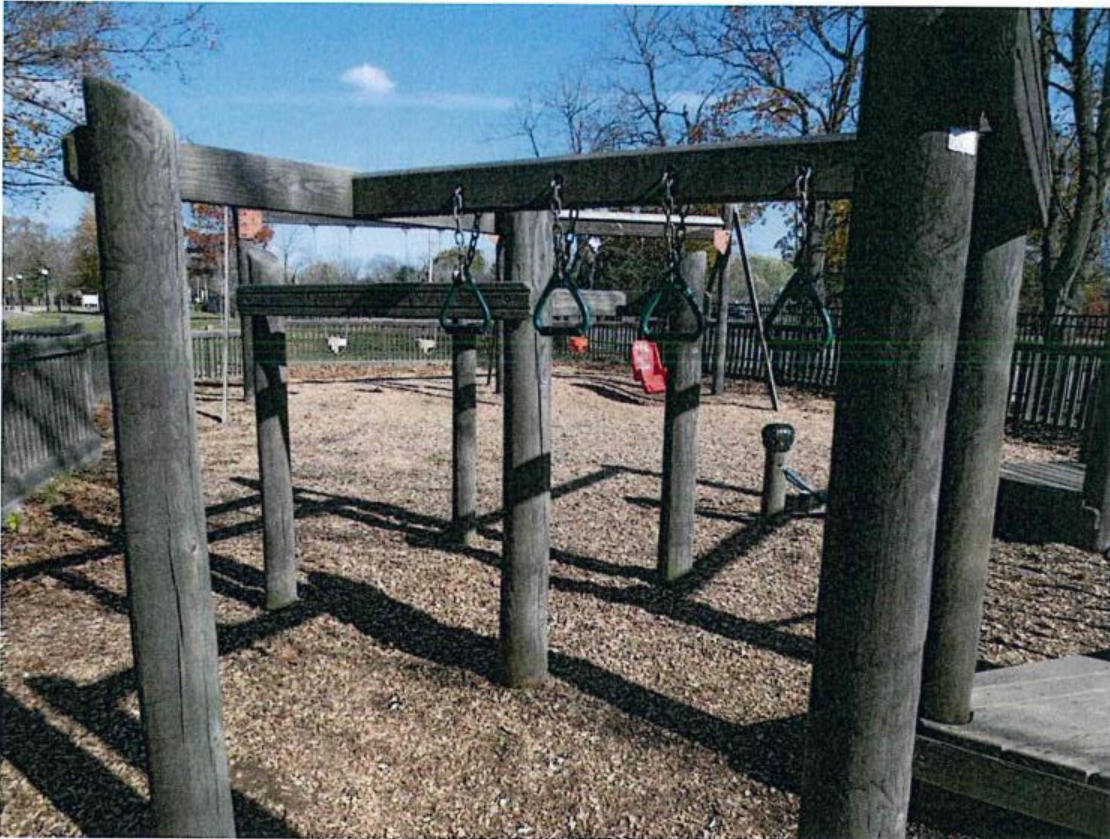
**Equipment type/name:** Low Rings

Original Wood Framing is weathered, cracked and splintered. Holes are elongated. Original rings, chains and quick links are worn and rusted.

Replace with manufactured version

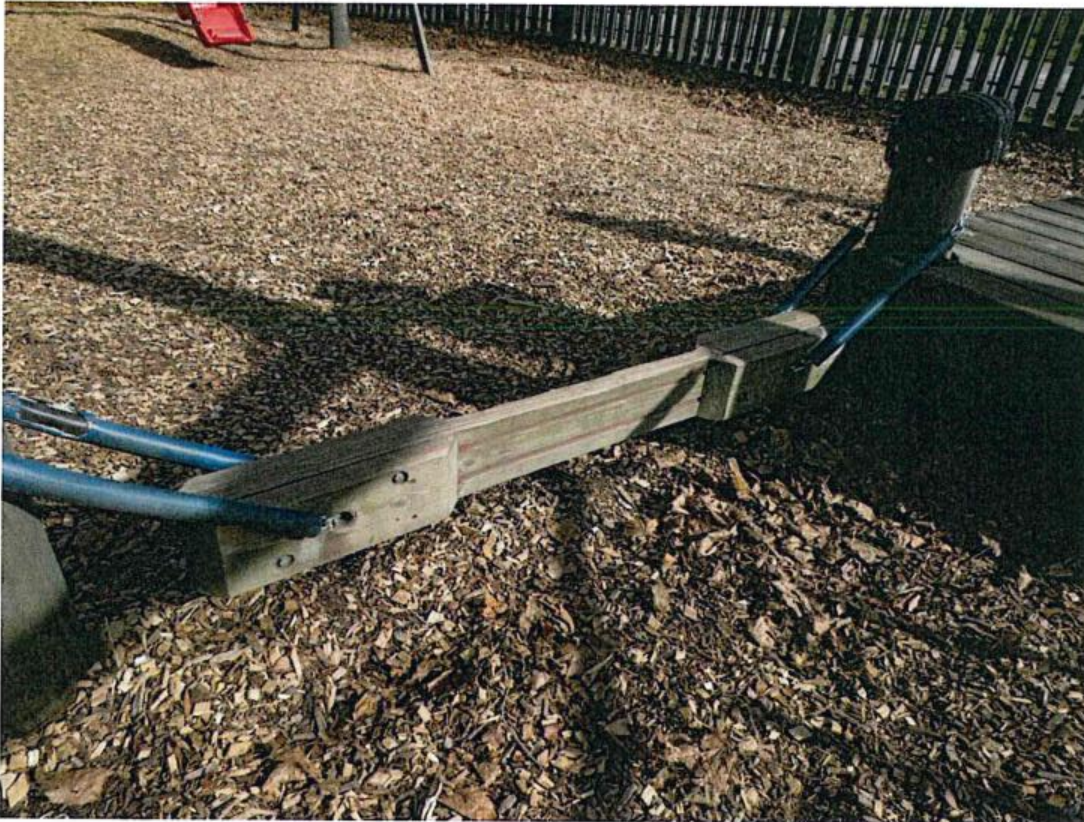
**Equipment type/name:** Balance on Chains

Original Wooden Balance on Chains is weathered and worn. Holes from chains are elongated. Chains and hose have been replaced, but new hose is starting to break down.

Replace with themed (fish?) wiggly platform

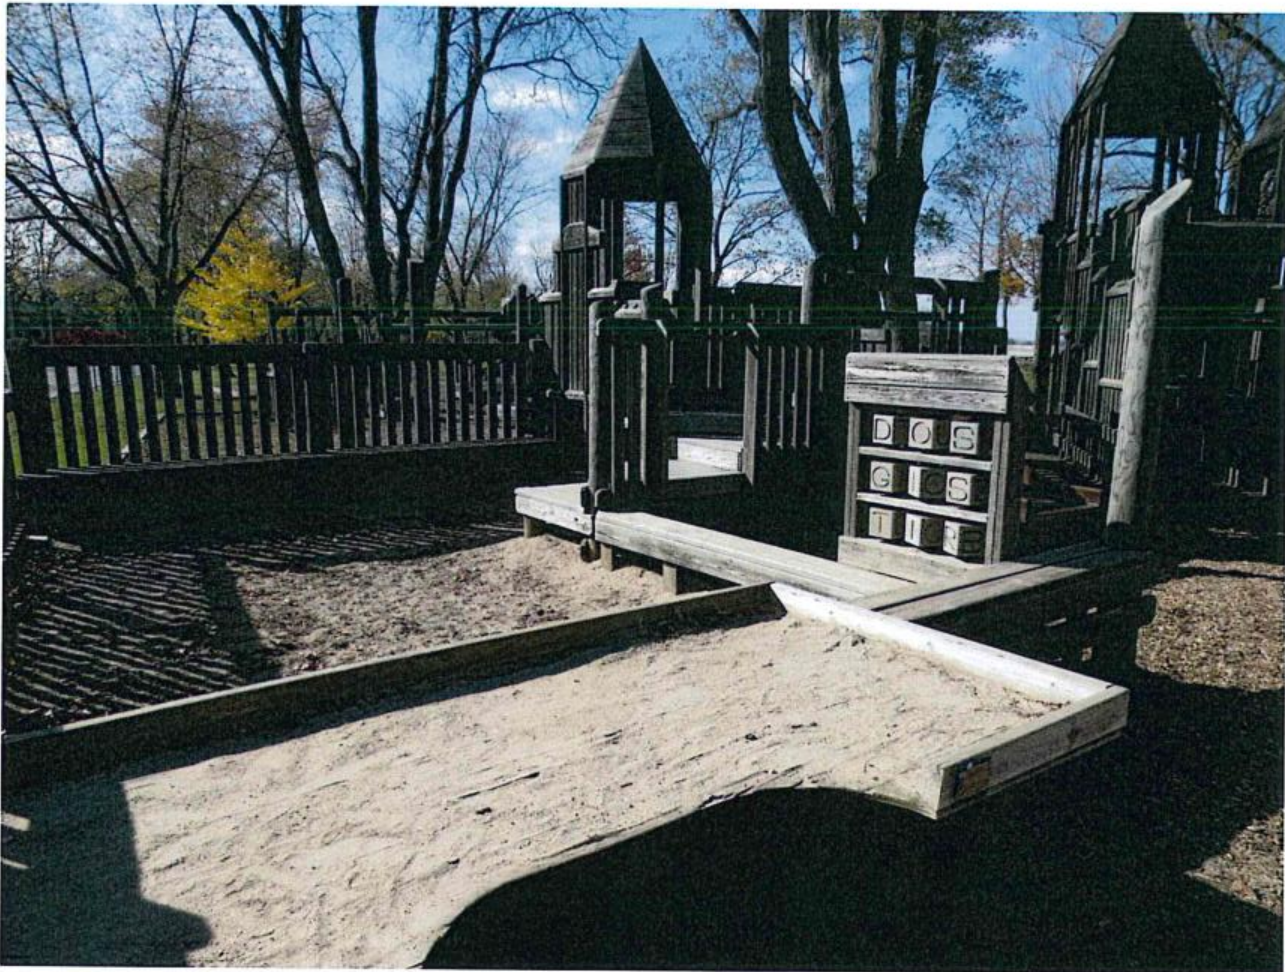
**Equipment type/name:** Sandbox and Sand Table

Existing sandbox and associated play area is obsolete and somewhat of a nuisance. Debris and garbage accumulate there and the sand gets thrown out into the main play are and gets mixed with the safety surfacing

Replace with new "Tot Lot" age-appropriate apparatus.
