DISCUSSION DRAFT
EXECUTIVE SUMMARY

CRYSTAL LAKE
CLEAN LAKES PHASE I PROTECTION PLAN

HEY AND ASSOCIATES, INC.

JULY 3, 2007

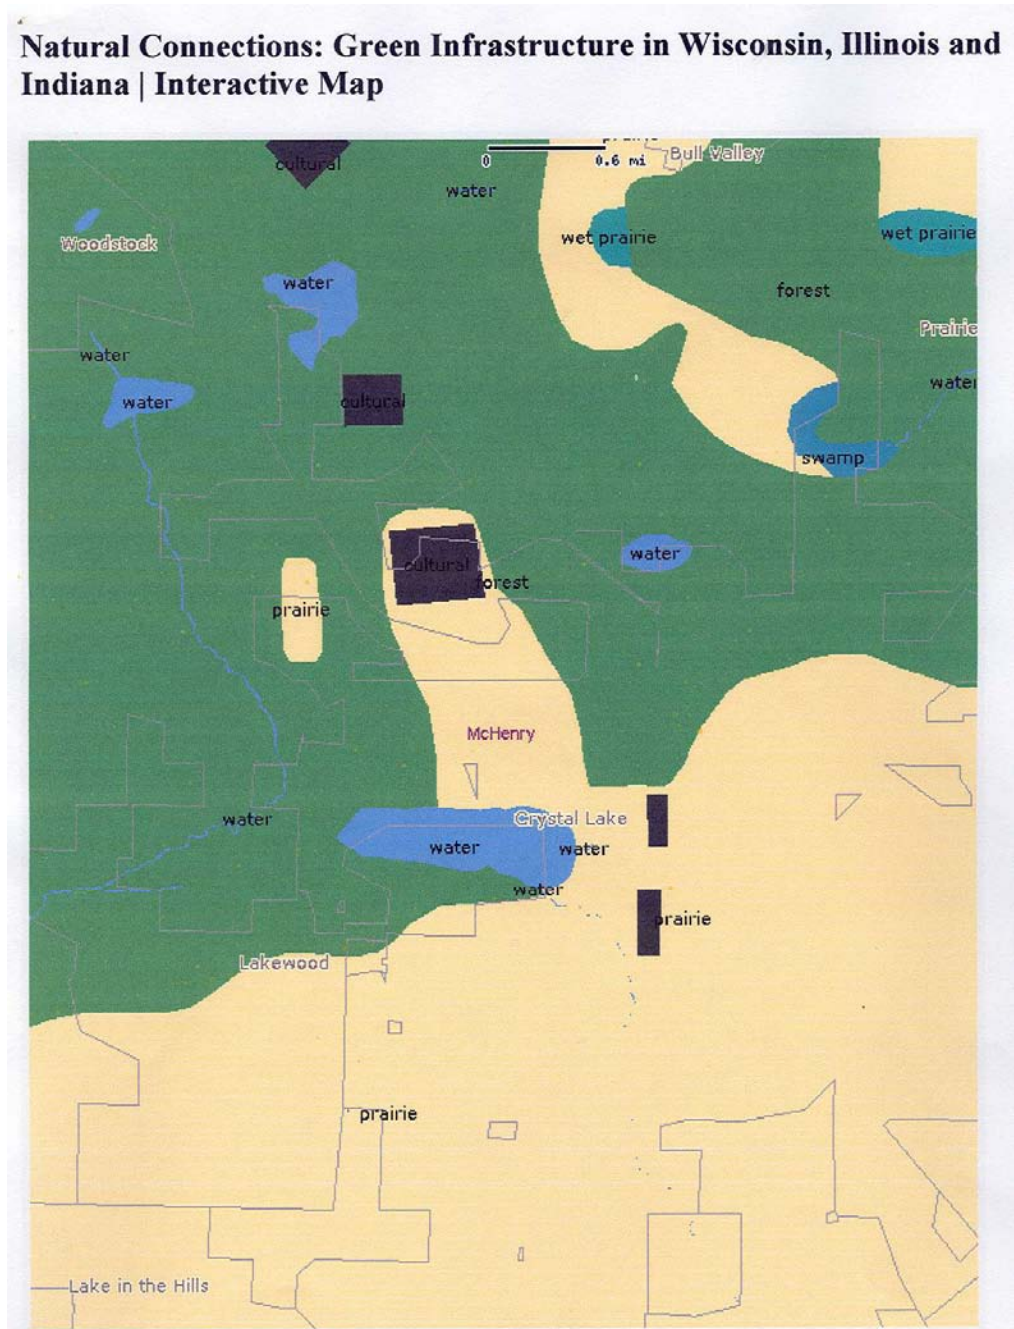
Figure E-7
Pre-settlement Vegetation Crystal Lake Watershed

At the time of European settlement in around 1840, the entire Crystal Lake watershed was entirely oak forest or prairie as shown on Figure E-7. Within a decade of settlement, most of the oaks and the entire prairie had been cleared for farming. In 1917, the CLDD built an extensive tile network to drain the land to facilitate even more agriculture (Figure E-8). Around the early 1900s, Crystal Lake built storm and sanitary sewers on the east end of the lake (Figure E-9). Crystal Lake also built storm sewers to the lake at Cove Pond and the Woodland Wetland. Fortunately, these are the only municipal storm sewers that lead into the lake. In the early 1930s, Lakewood built storm and sanitary sewers on the south side of the lake around Broadway Avenue (Figure E-9).

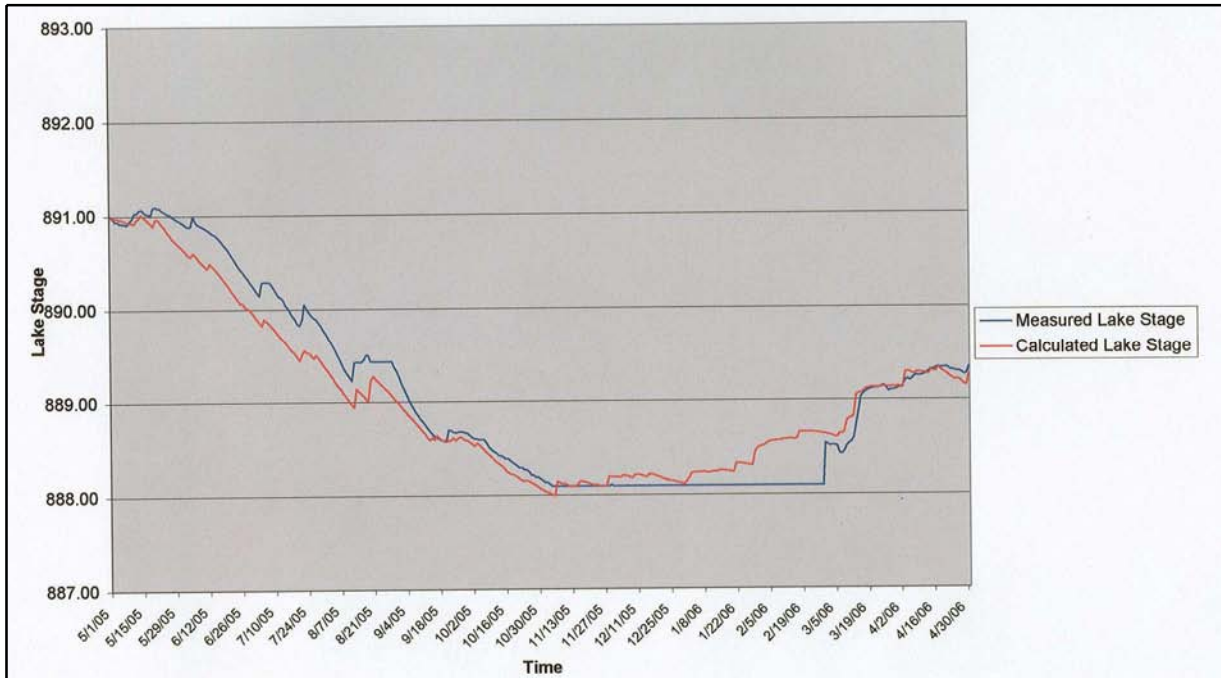
Figure E-12
Water Budget – Adjusted Flows

To confirm the water budget, measured lake levels were compared with lake levels calculated from the hydrology data collected. The results are shown in Figure E-12 and indicate a very high correlation between measured and calculated lake levels.

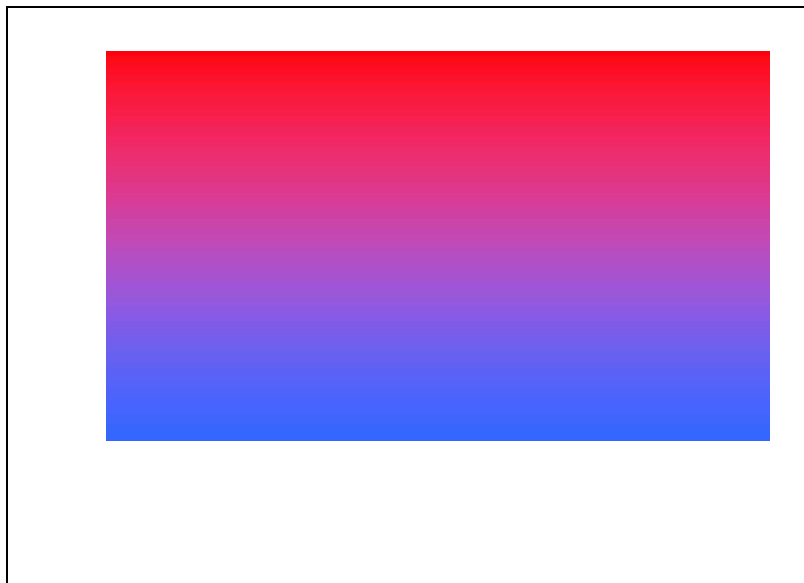
Figure E-14
Clarity, Phosphorus, and Trophic State Trends for Crystal Lake Mid-lake Sampling Station

The data collected during the Clean Lakes study were compared with historical data on clarity, total phosphorus, and trophic state to see if any negative or positive trends were apparent. The comparison is shown in Figure E-14 and indicates that no trends were apparent which means that the lakes water quality appears to have been stable over the last 20 years.
